NASA Technical Paper 1481

Light Airplane Crash Tests at Three Pitch Angles

Victor L. Vaughan, Jr., and Emilio Alfaro-Bou

NOVEMBER 1979

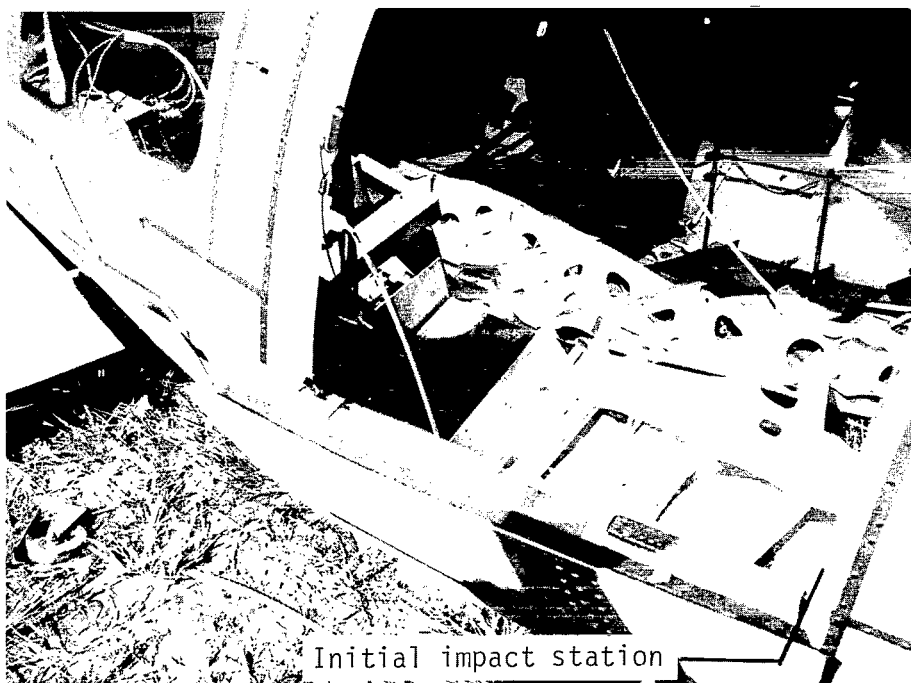
L-74-8079.1

Flat test.— The flat-test specimen made first ground contact in a 4° pitch attitude, which resulted in initial ground contact at grid coordinate 21. The accelerometer at 19B9N (see fig. 19(b)) responded on initial ground contact. The specimen pitch attitude changed less than 1° during impact. Loads were progressively applied to the floor beams such that the fire wall (8B9N) was the last frame to contact the ground at 0.032 sec after initial ground contact. Very high accelerations were experienced in the passenger compartment aft of the main spar, with the greatest acceleration of $-150g$ occurring in the third- and fourth-passenger location. These passenger-compartment accelerations were considerably higher for the flat specimen ($-150g$ to $-50g$) than for the pitch-down specimen ($-80g$ to $-20g$). The accelerations at the fire wall (8B9N) were very small. The accelerations at the first frame (2B9N) and second frame (5B9N) in the nose of the airplane were transmitted through the floor beam and attached structure since those two frames did not contact the ground during impact. The intensity of the first peaks exhibited the same trend but in the reverse direction as that in the pitch-down test (i.e., the intensity decreased as the ground contact moved forward). Maximum fuselage expansion occurred at 0.069 sec when all vertical velocity of the structure had ceased. There are no indications in the acceleration data of the main wing spar breaking (see fig. 17(d)), even though there was complete failure in the upper flange of the spar.

(b) View looking at floor through fuselage door.

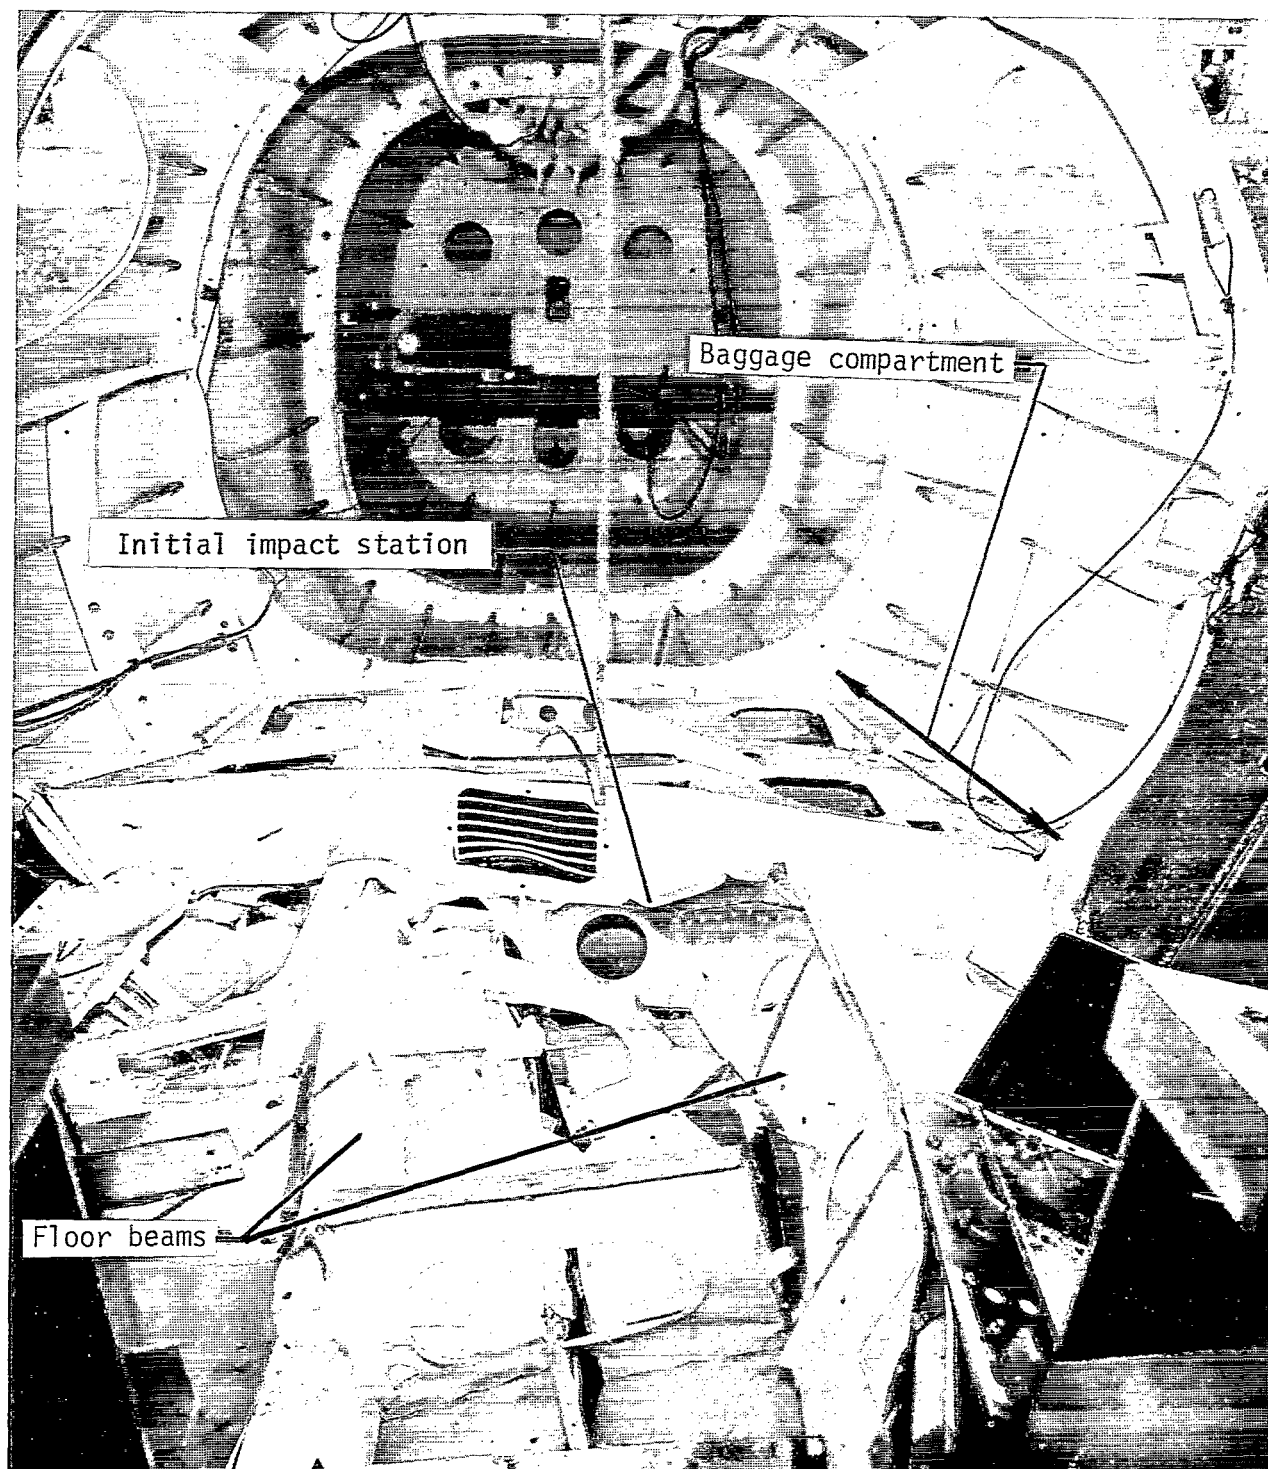
L-79-306

(c) View looking aft.

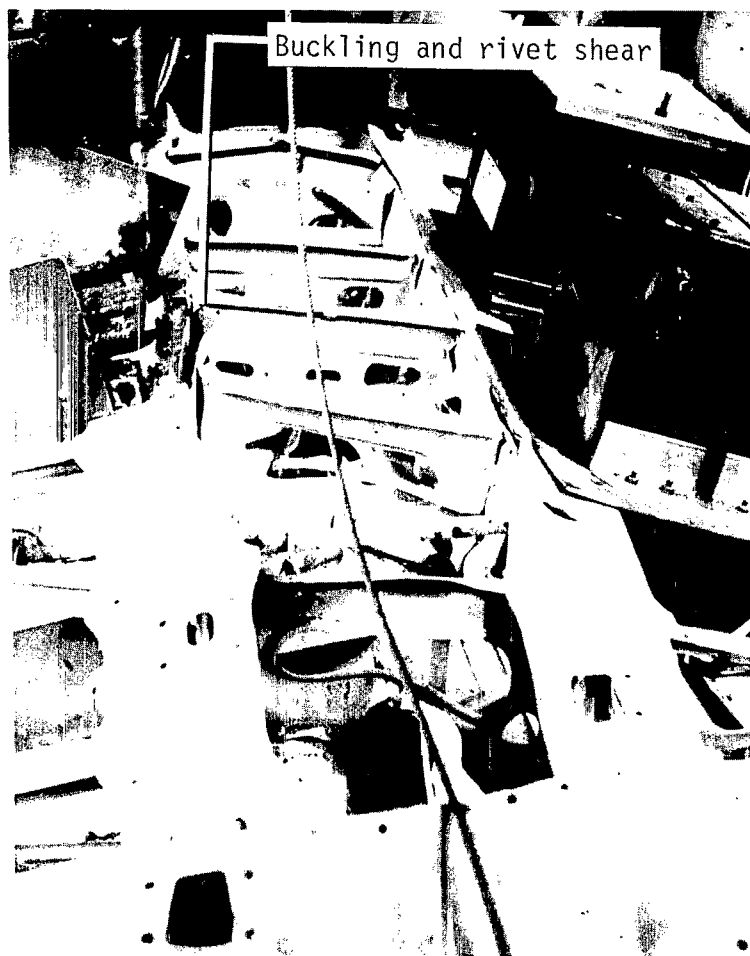
L-79-307

Pitch-up test.— The photograph from the pitch-up test that was taken from the aft end of the fuselage looking forward (fig. 18(a)) shows the same type of outboard-rotated position of the seats as previously noted. The second-passenger dummy used in the previous tests was simulated with lead masses in this test. Although the external pictures (fig. 15) indicated less structural damage than in the pitch-down and flat tests, the pictures of the internal structure in the vicinity of the door and baggage compartment (fig. 18(b)) show damage similar to the flat test. The floor damage in the passenger section of the fuselage (fig. 18(c)) shows some structural buckling, rivet shear, and total failures of the cross members between the longitudinal beam, but little damage to the beams themselves.

(c) View of floor in aft section of cabin.

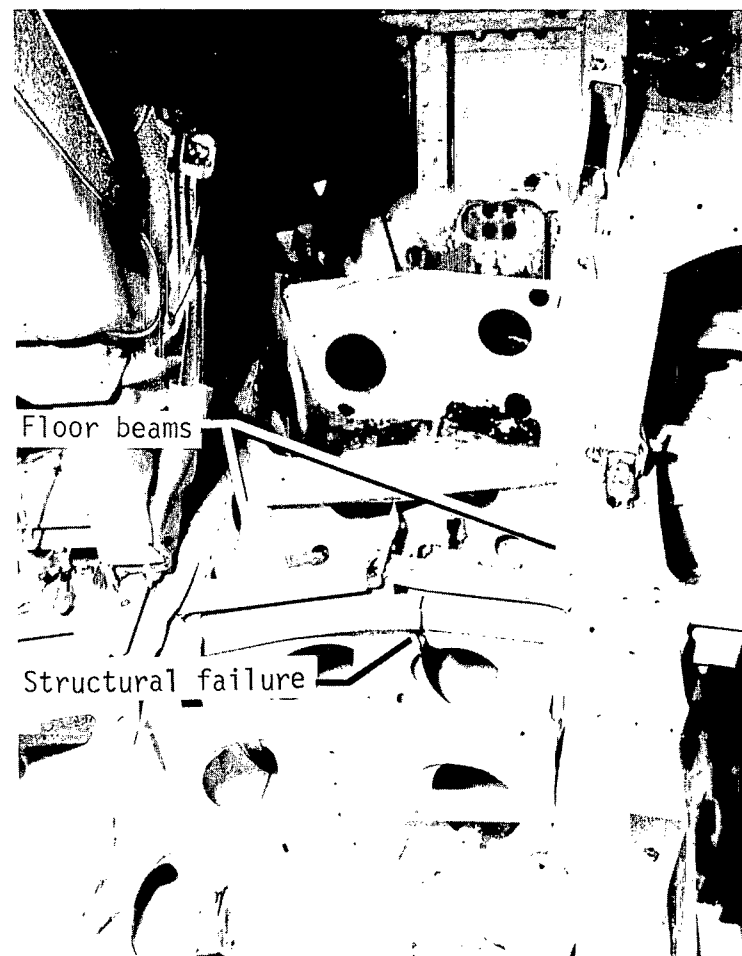
L-75-3748.1

(d) View of floor between first- and second-passenger seats.

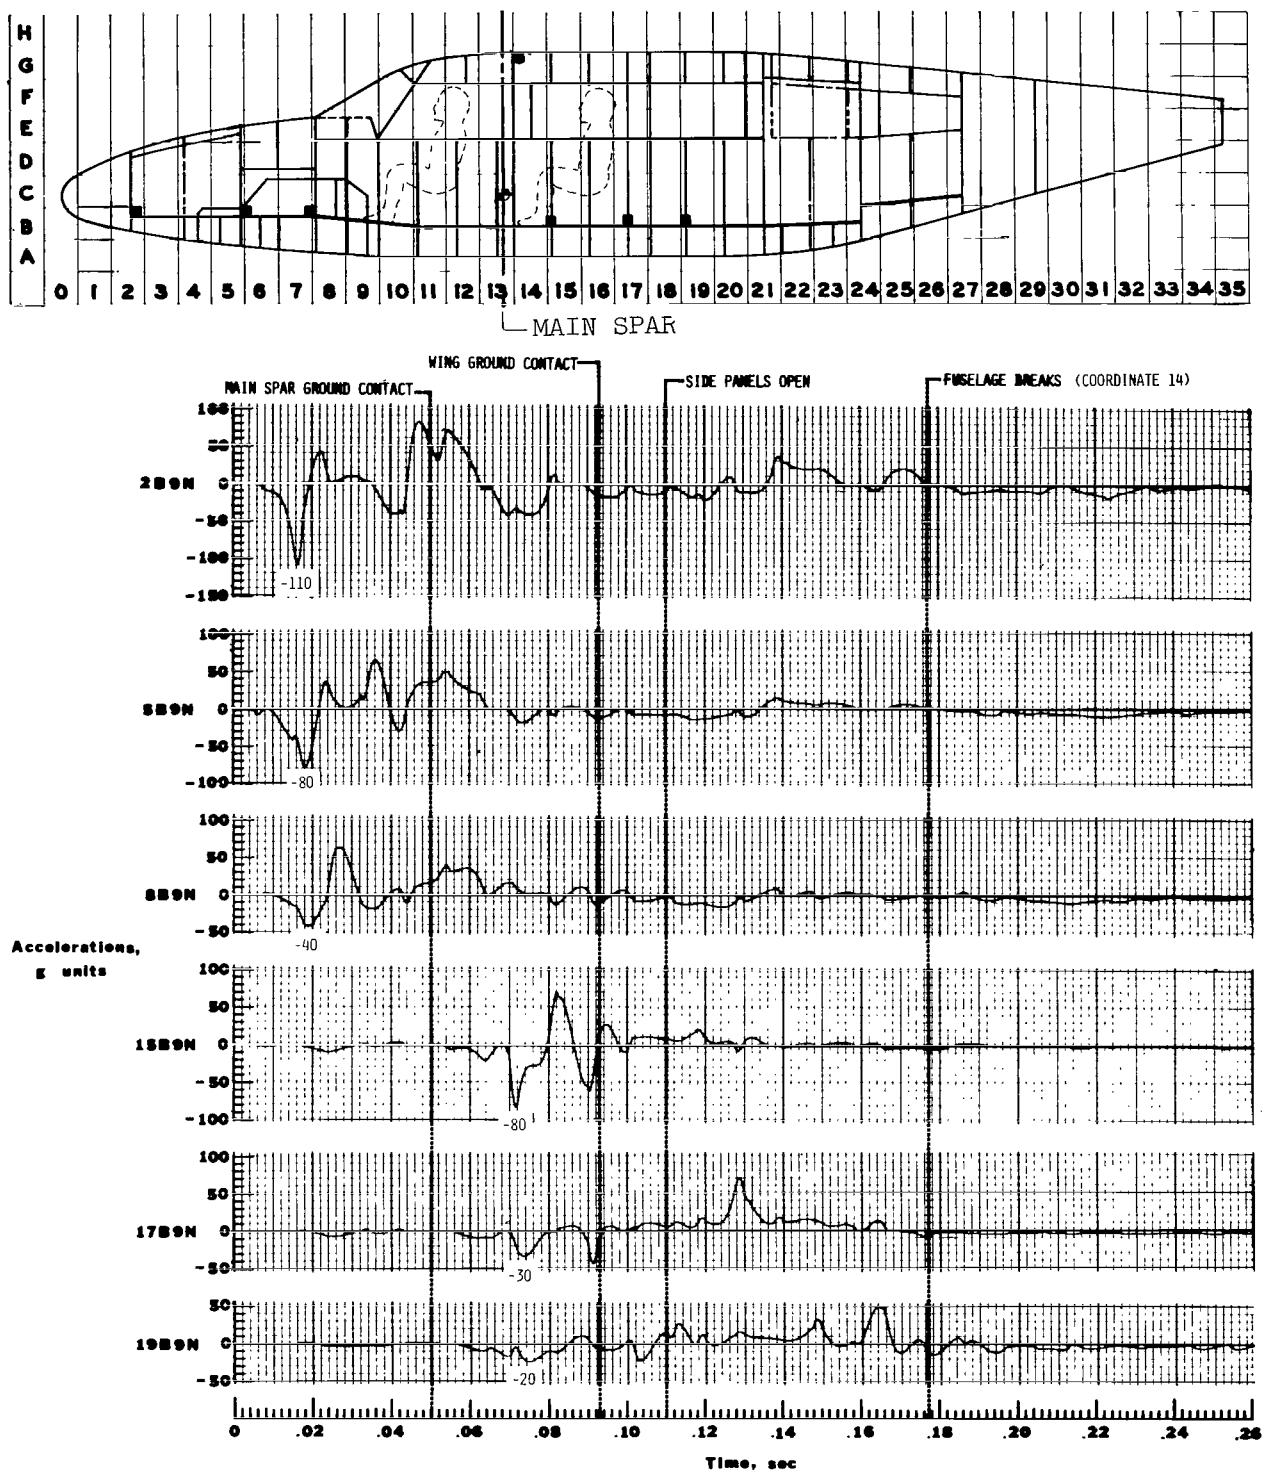
(a) Pitch-down test.

Pitch-down test.— The pitch-down test specimen made first ground contact in a -12° pitch attitude such that the first fuselage frame (2B9N) of figure 19(a) responded to the impact first, followed by the impact of consecutive frames back to the fire wall (8B9N). The acceleration histories show that the application of the major impact acceleration at the first frame peaked at 0.016 sec after ground contact, with a magnitude of $-110g$. The acceleration of the floor beam at the fire wall peaked at 0.019 sec, with a magnitude of $-40g$. The main spar contacted the ground at about 0.05 sec into the impact. During this time, the specimen continued to pitch to an attitude of -9° . The main spar acted as a fulcrum when it contacted the ground. This caused the angular velocity of the passenger compartment behind the spar to increase and the nose of the specimen to rotate off the ground, thus relieving all direct loadings in the nose section. The intensity of the accelerations decreased from $-110g$ to $-40g$ as the ground contact moved rearward to the spar. The floor from the spar (frame coordinate 13) through the third-passenger location (frame coordinate 19) was in ground contact within 0.08 sec after initial ground contact. During this time period, the spar buckled near the center of the cabin as the wing twisted and rotated down.

Figure 19.- Histories of the floor-beam normal accelerations.

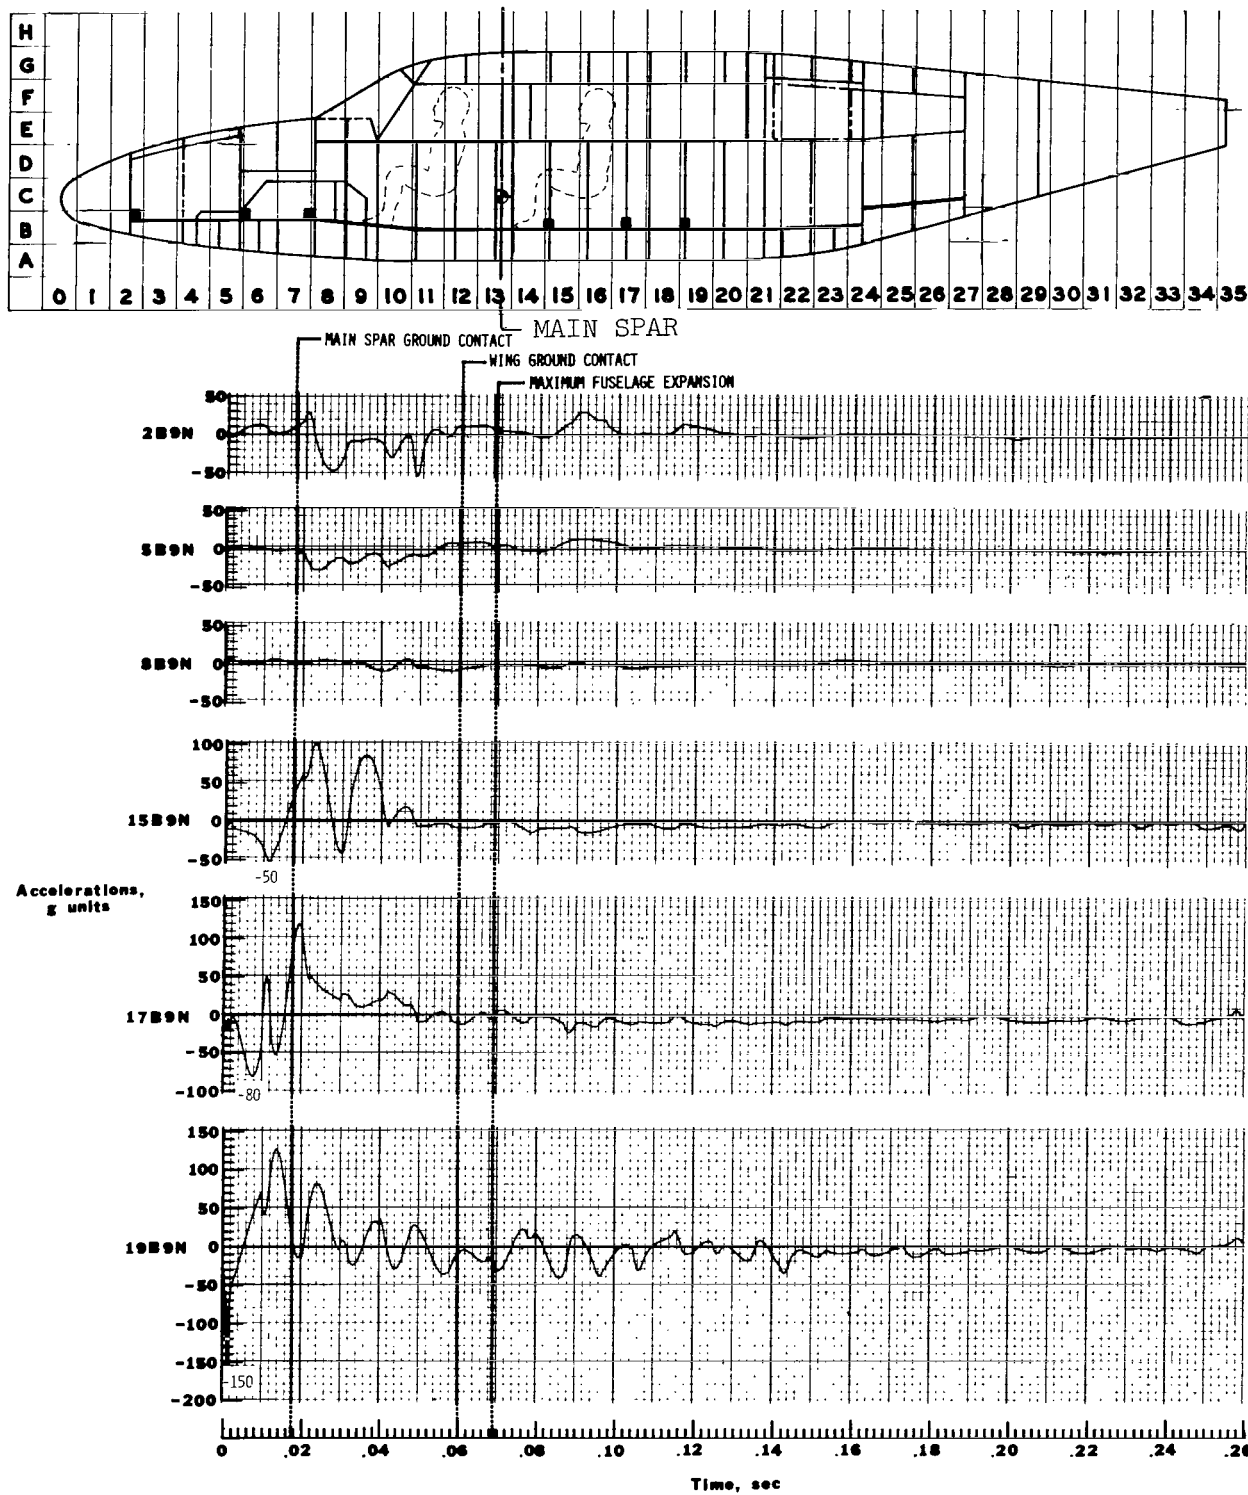
(b) Flat test.

Figure 19.- Continued.

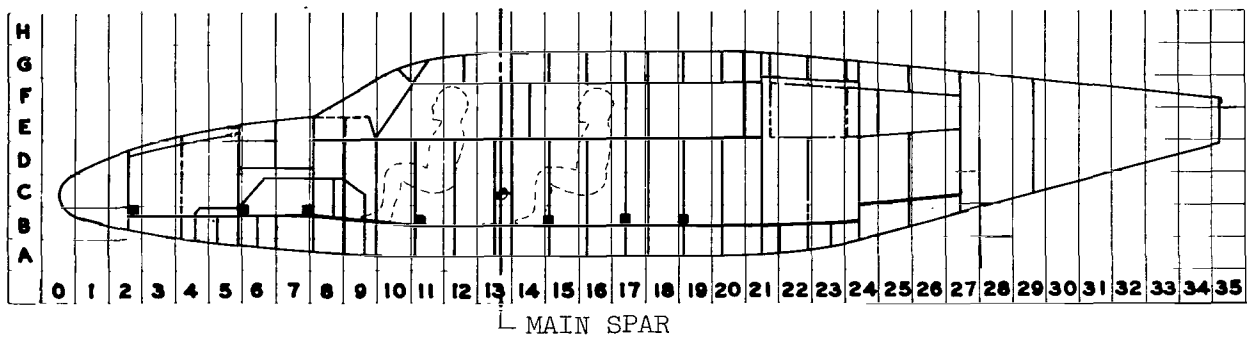
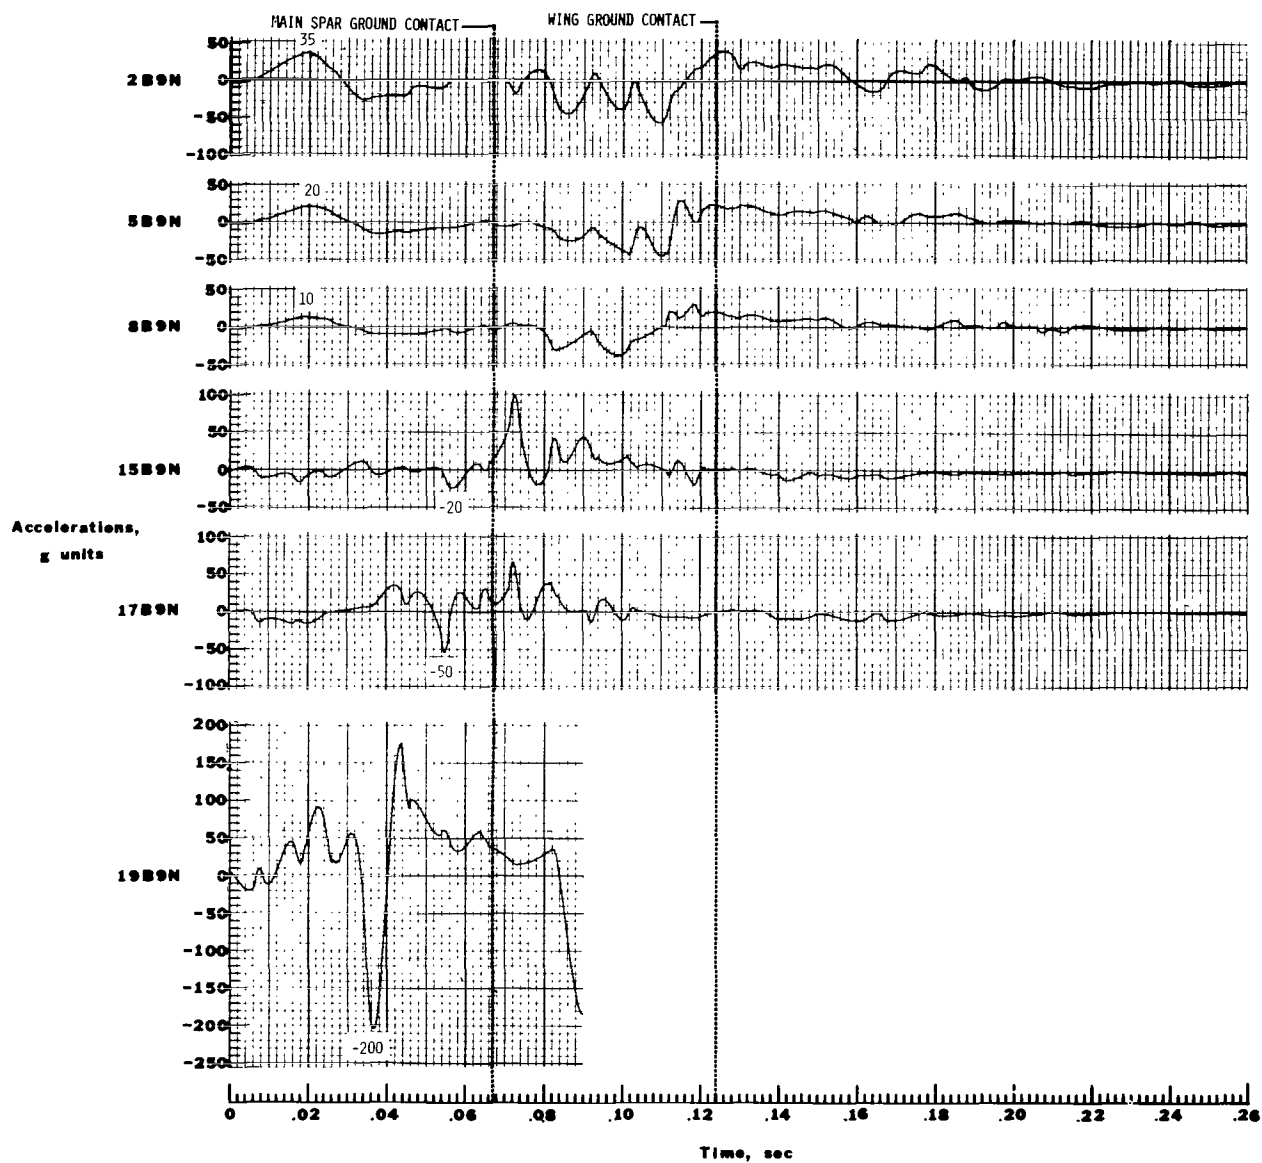
(c) Pitch-up test.

Pitch-up test.— The pitch-up test specimen made first ground contact along the slope of the lower surface of the tail section. The frame at grid coordinate 24 (fig. 19(c)) was extensively damaged on initial ground contact, and it took about 0.03 sec for the ground contact to move forward in the passenger compartment, when there was a major response at accelerometer 19B9N. The accelerations at this frame were very high ($-200g$), but as the ground contact moved further into the compartment, the accelerations at the succeeding frames were much lower ($-50g$ to $-20g$) and of about the same magnitude as those of the flat test. It may be noted that the accelerations at the frames in the nose section (2B9N, 5B9N, and 8B9N) responded in the positive direction before the main spar contacted the ground at 0.067 sec into the impact. The accelerations of $35g$, $20g$, and $10g$ at frames 2B9N, 5B9N, and 8B9N, respectively, indicate a very high downward pitching rate as a result of the initial high nose-ground contact of 14° pitch. After the main spar contacted the ground, these same forward frames showed negative accelerations due to ground contact. By the time the wing tips made ground contact, the nose frames were already in ground contact, and the airplane continued to rock forward until only the nose section was in ground contact. Thereafter, all accelerations were very low as the airplane rocked back onto the bottom of the fuselage.

Figure 19.- Concluded.

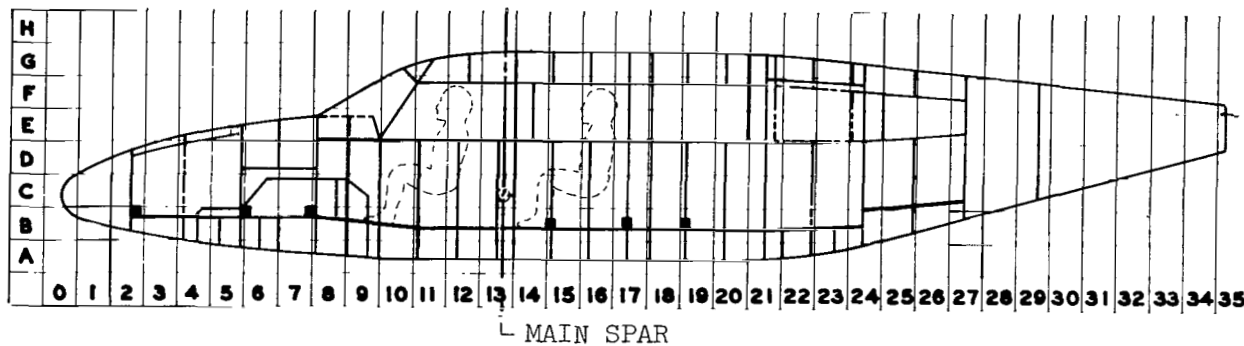
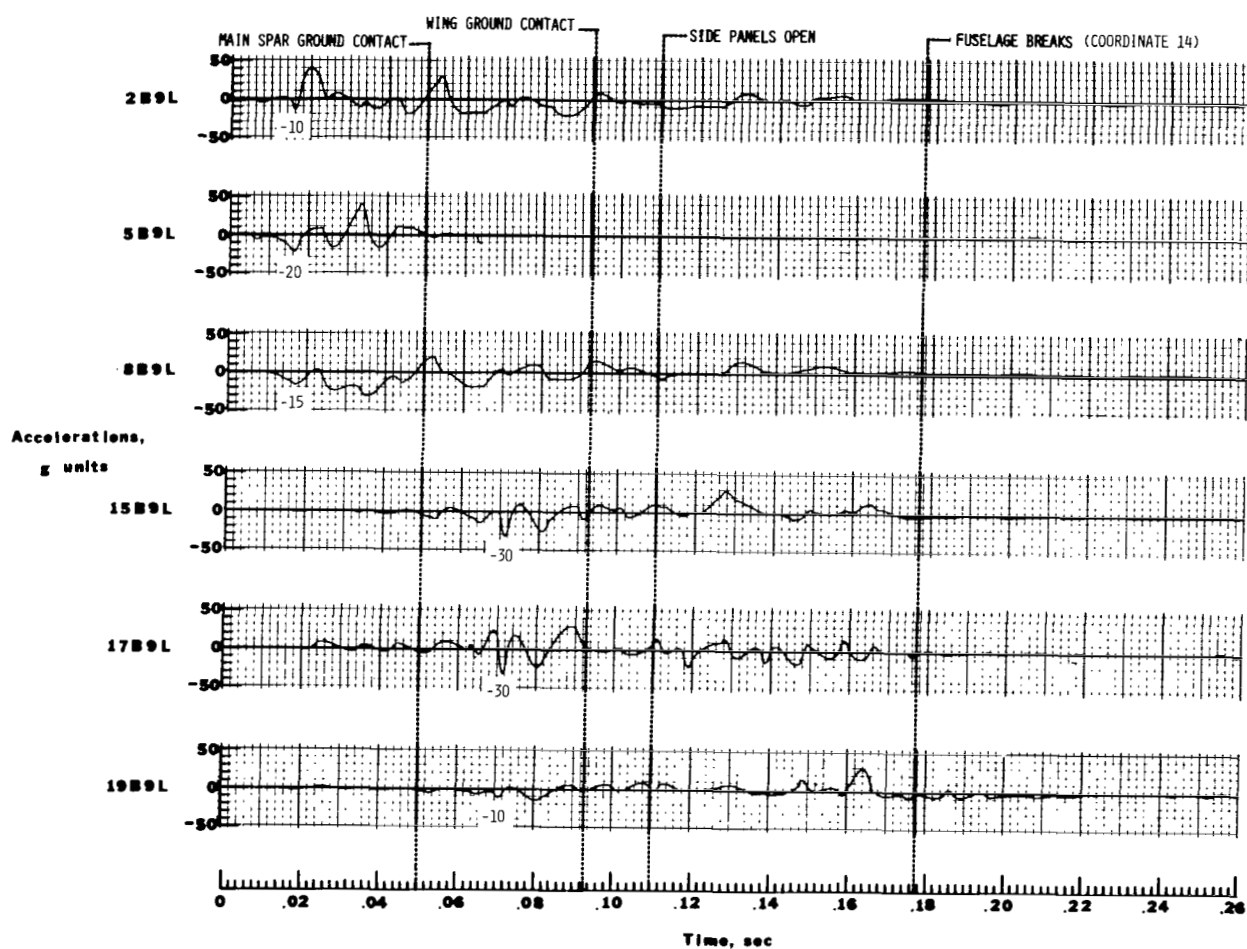
(a) Pitch-down test.

Pitch-down test.— Figure 20(a) shows the response of the longitudinal accelerometers to impact for the pitch-down test. The magnitude of accelerations in the nose (2B9L to 8B9L) was very low during the deformation of the nose structure, which ended at about 0.02 sec into the impact. The later peaks were associated with the rebound of the nose section and the acceleration transmitted through the structure. Behind the main spar, structural deformation was felt over a much longer time since ground contact at 19B9L started about 0.08 sec after initial ground contact and continued for a period of 0.065 sec, or until maximum fuselage expansion at about 0.145 sec. The longitudinal acceleration traces do not show definite indication of specific structural failures.

Figure 20.- Histories of the floor-beam longitudinal accelerations.

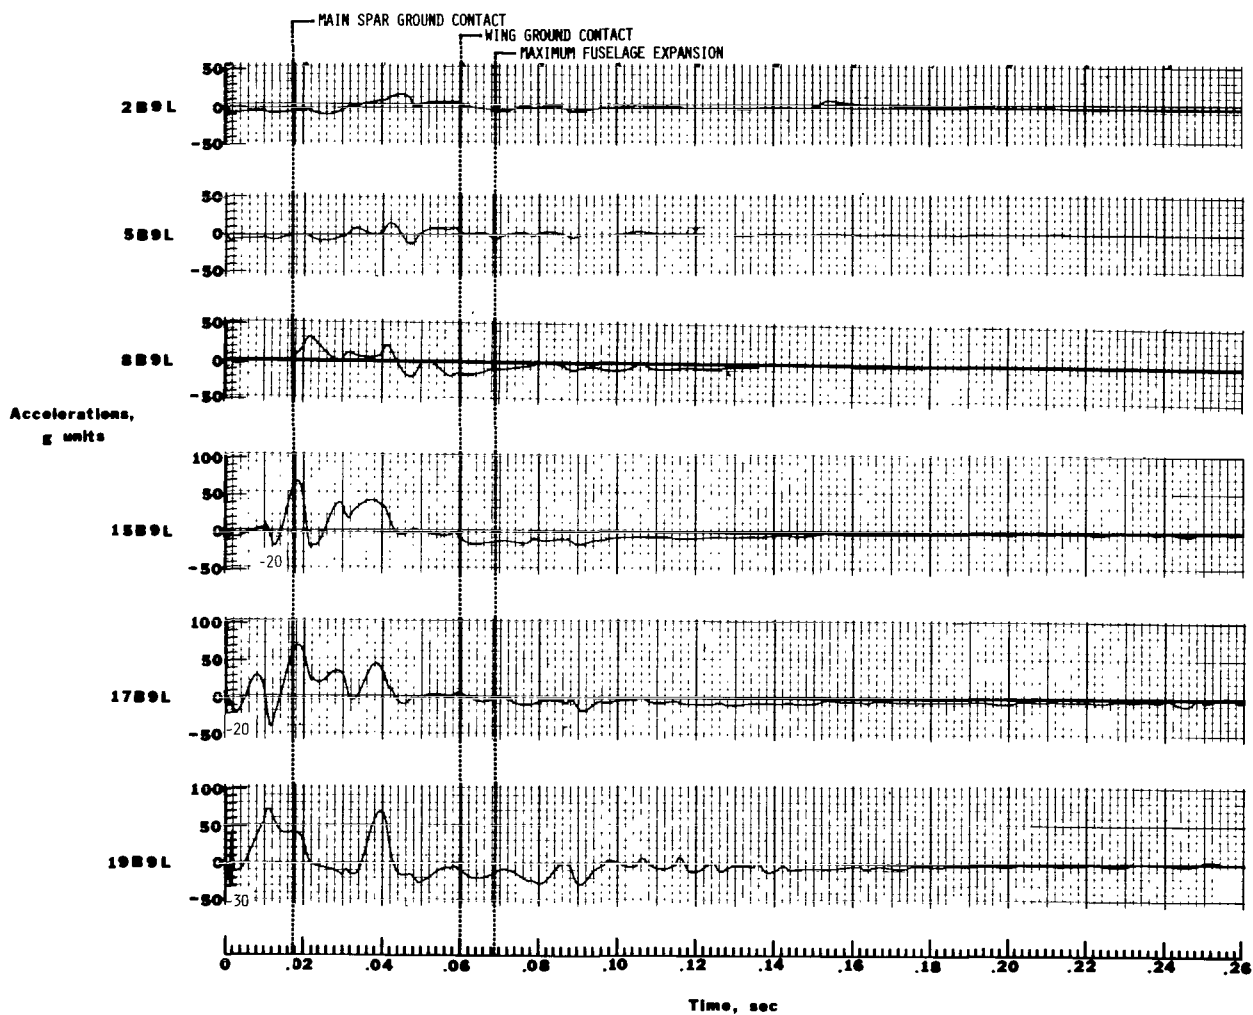
(b) Flat test.

Flat test.— Figure 20(b) shows the longitudinal acceleration histories for the flat test. The passenger-compartment accelerations indicate the effect of the 4° pitch attitude at initial impact by the slight time difference as the ground contact moves forward from 19B9L to 8B9L. The magnitudes of the accelerations aft of the main spar were nearly the same. The acceleration at 8B9L was smaller, and since this was the last frame to contact the ground, the very low accelerations at frames 5B9L and 2B9L were transmitted through the floor beams and associated structure. The longitudinal accelerations in the passenger compartment were considerably higher for the flat specimen than those for the pitch-down specimen.

Figure 20.- Continued.

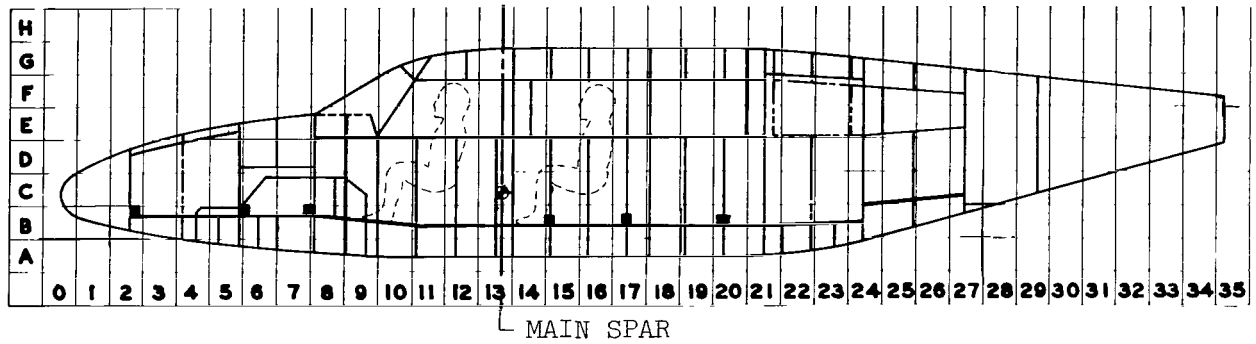
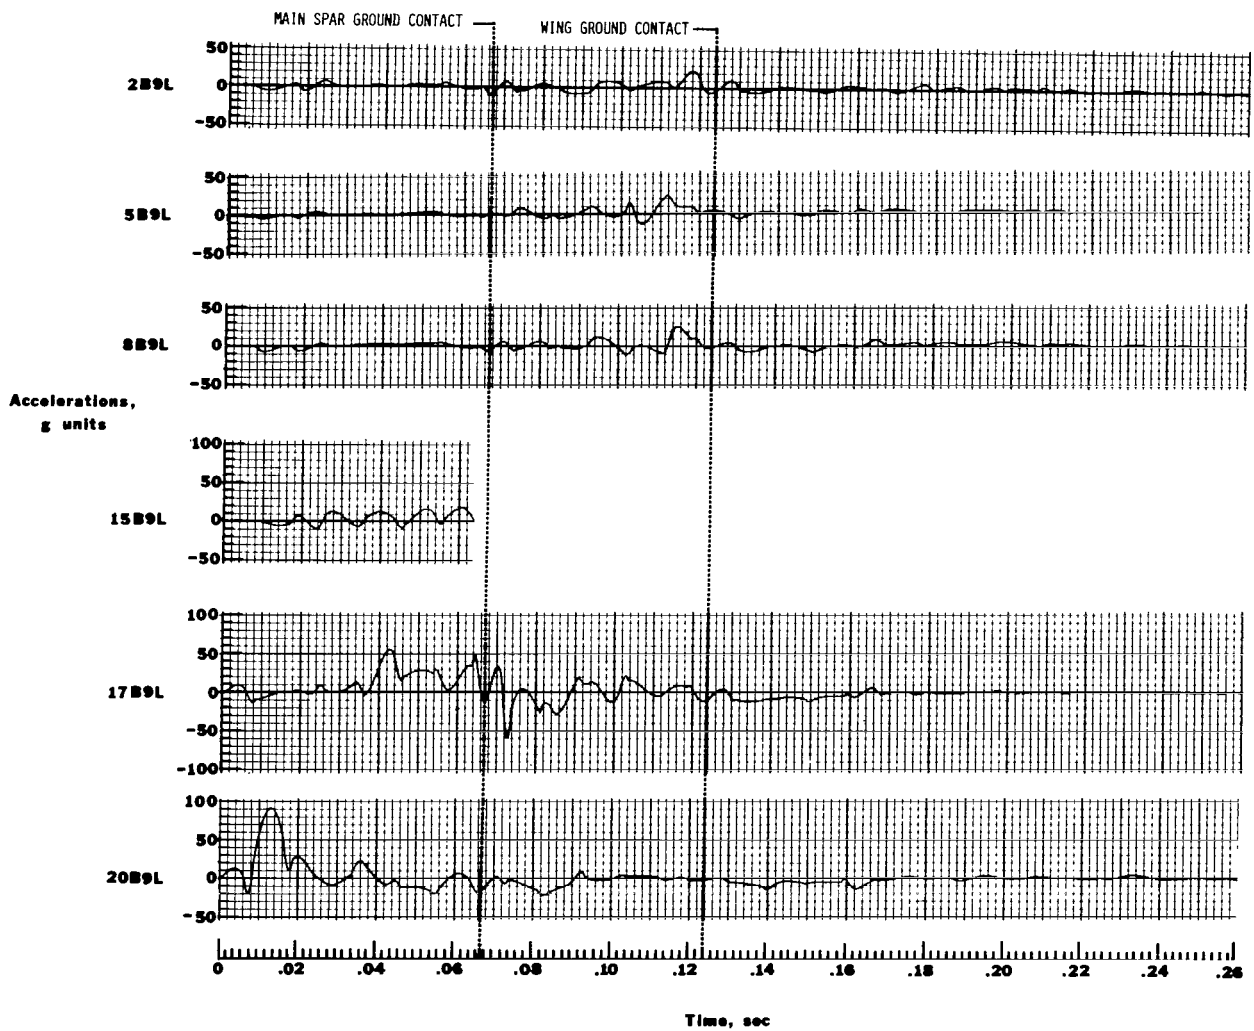
Figure 20.- Concluded.

Pitch-up test.— Figure 20(c) shows the longitudinal acceleration histories for the pitch-up test. The last frame in this figure is noted as 20B9L, instead of 19B9L as in figures 20(a) and 20(b). Since these frames are close together and are alike in structural features, the accelerations should be comparable. The lack of a definite pattern for the accelerations appears to be the result of the rocking motion of the airplane during impact. In general, the magnitude of these accelerations appears to fall between those for the pitch-down and flat tests.

(c) Pitch-up test.

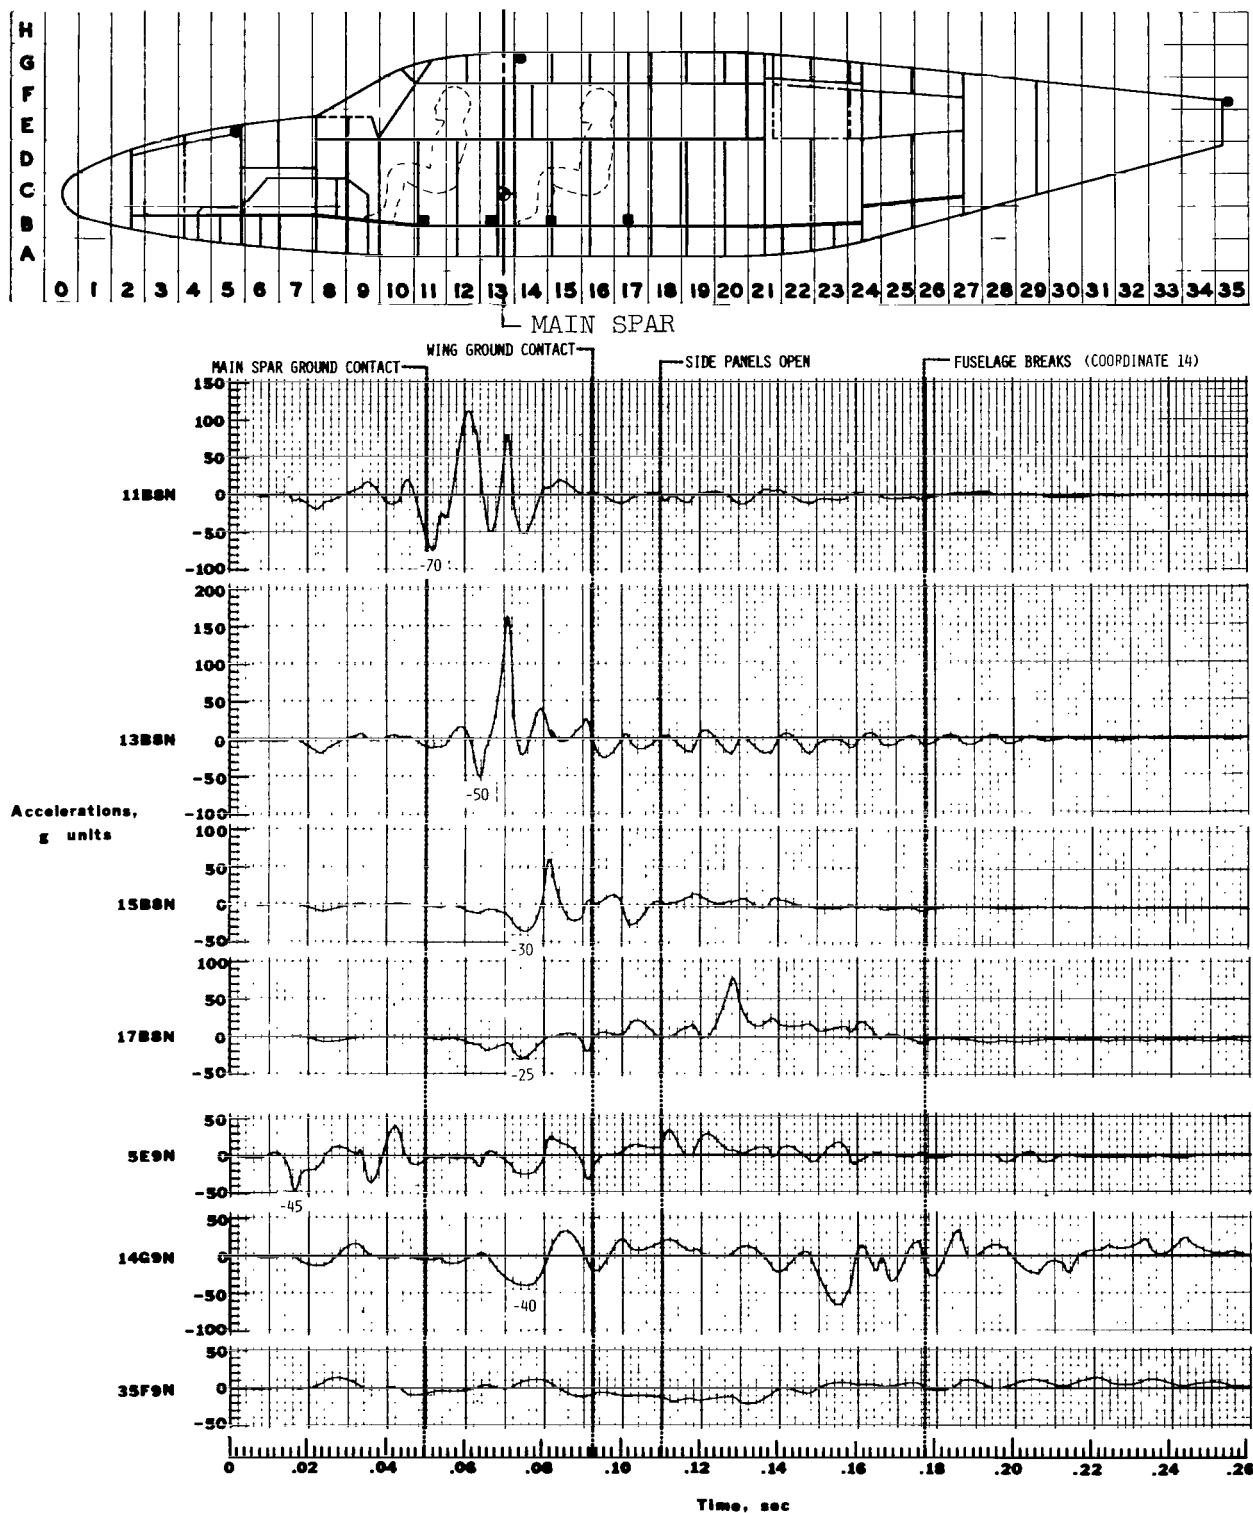
Figure 21.- Histories of roof and floor normal accelerations.

Accelerations on the floor (other than the floor beam) and along the roof are presented in figure 21 in the normal direction and in figure 22 in the longitudinal direction. The accelerometers at frames 11B8 and 13B8 were mounted on the aluminum floor boards between the pilot's fore and aft seat legs. As a result of this mounting, the acceleration traces show an oscillatory behavior that is typical of a local vibration. The large acceleration peaks are a result of the impact superimposed on the oscillatory traces. The window side

(a) Pitch-down test.

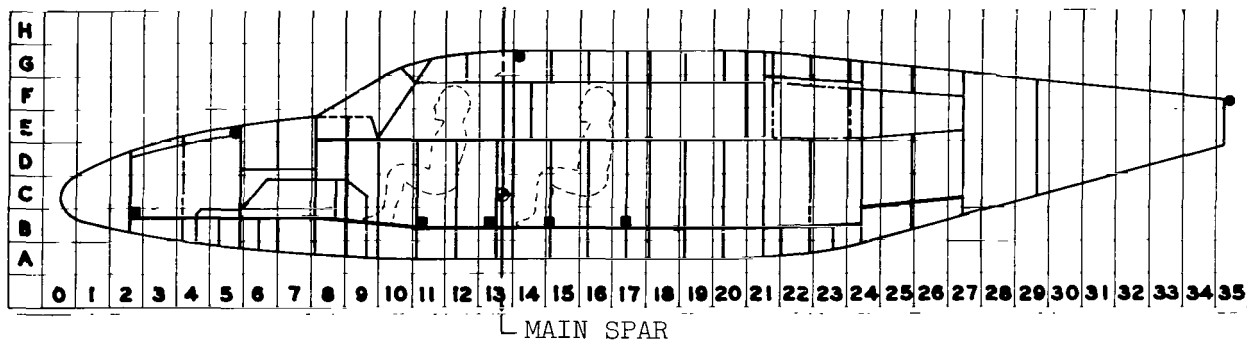
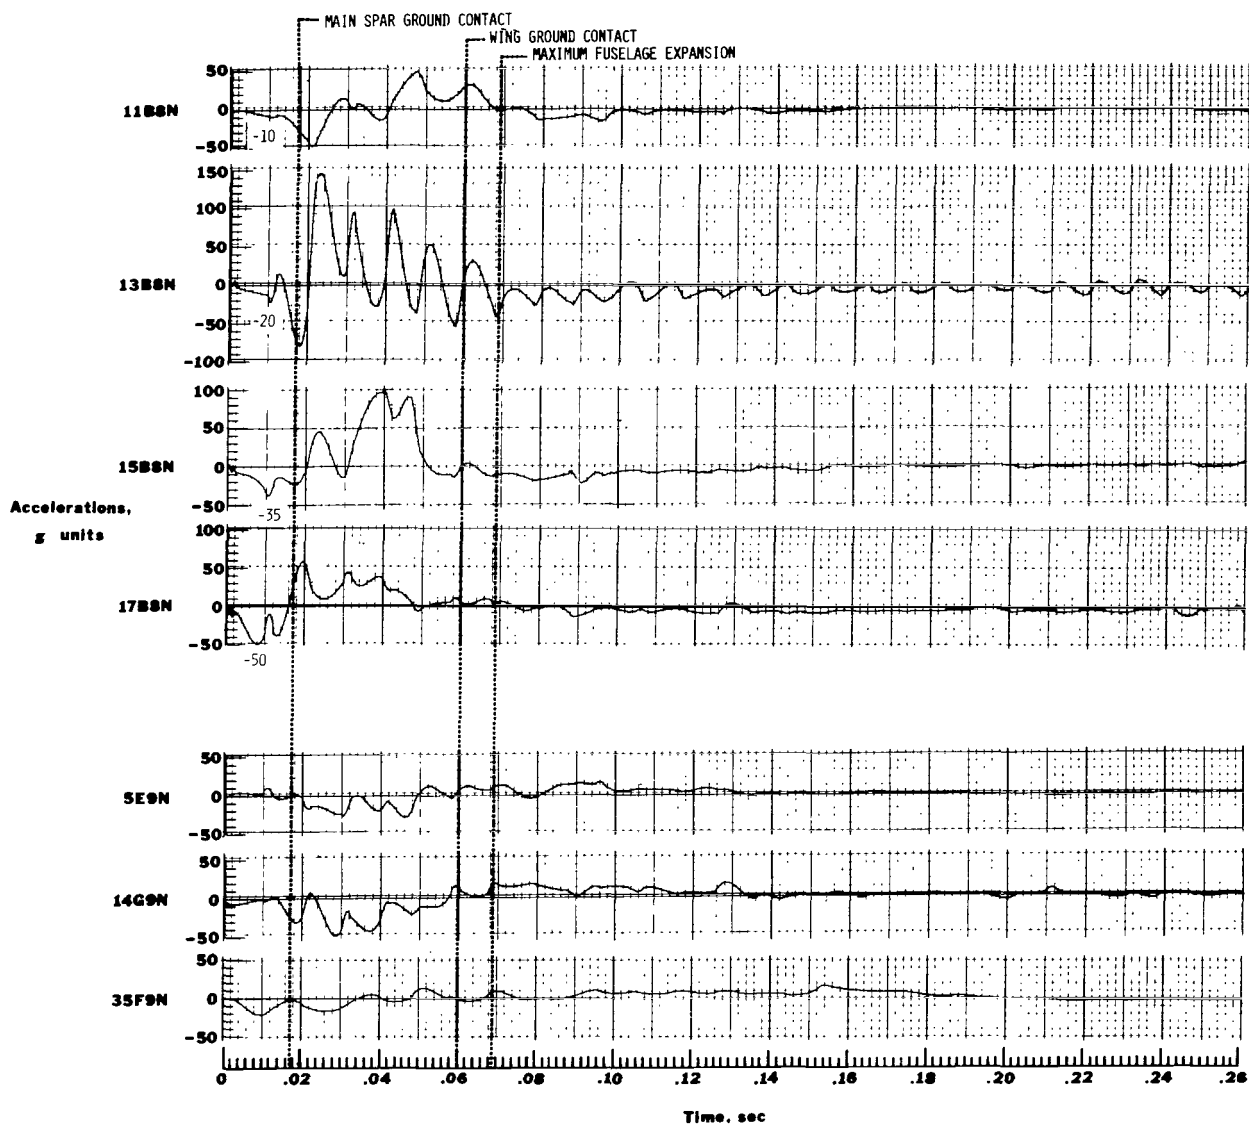
Figure 21.- Continued.

(b) Flat test.

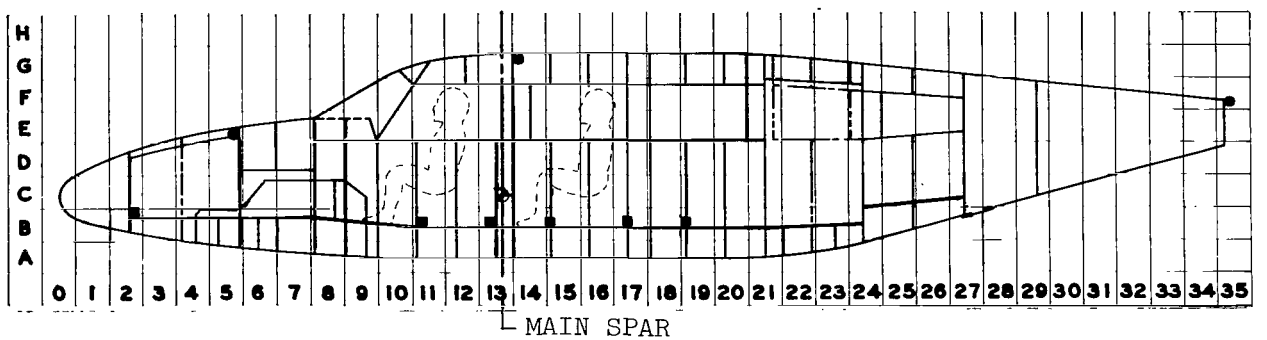
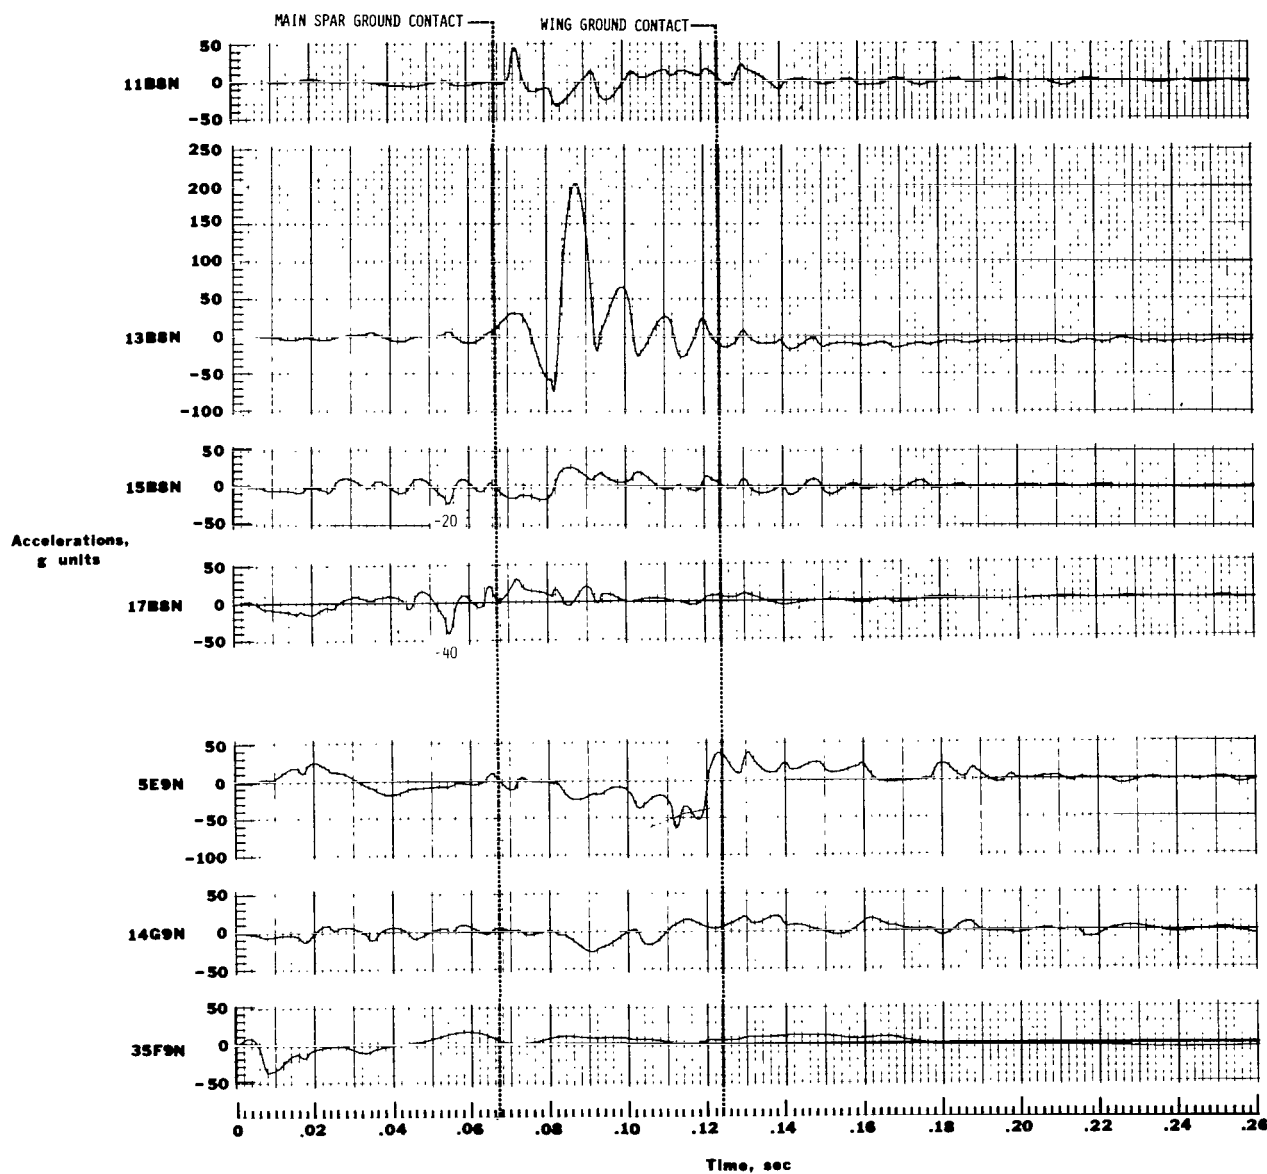
Figure 21.- Concluded.

(c) Pitch-up test.
